# Inspection Report

111 A St

San Diego, CA 92126

Prepared for: John Client

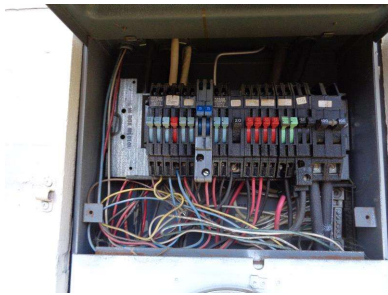
Size, 120/240 volt, rated at 100 Amperes, Brand, This property has a Zinsco brand electrical service panel. These panels and their breakers have a variety of problems including:- Arcing potential with aluminum bus bars and copper contacts on breakers· Bus bars made from aluminum that tend to oxidize and corrode· Breakers that don't trip under normal over-load conditions. At a minimum, recommend having a licensed electrician remove the breakers in the panel and evaluate the bus bars and breaker contacts. Recommend replacing damaged parts or the entire panel as necessary. If the panel isn't replaced, recommend installing a smoke detector above the panel. Recommend further evaluation by a licensed electrical contractor prior to removal of contingencies.

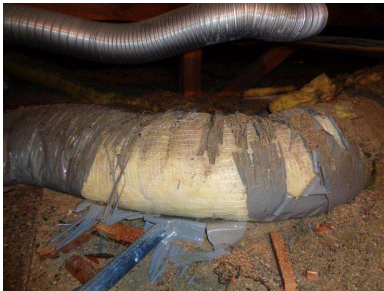
Plastic covered and insulated flexible ducting Conditions, Original duct system present. These ducts are usually very leaky. This hurts the efficiency of the units, causing shorter life expectancy and higher energy bills. The outer plastic covering on the conditioned air ducts was damaged. We recommend correcting the condition(s) noted. Recommend replacing duct system.

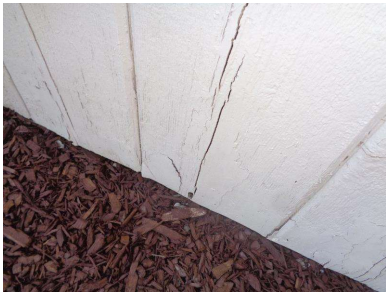
Combination of Stucco, Wood panels, CONDITIONS. Attention: The wood siding was damaged/deteriorated. These conditions are conducive to moisture intrusion/deterioration. Repairs or replacement needed.

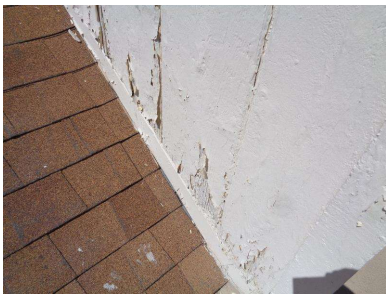
Combination of Stucco, Wood shingles, CONDITIONS, Attention: The wood siding was damaged/deteriorated. These conditions are conducive to moisture intrusion/deterioration. Repairs or replacement needed.

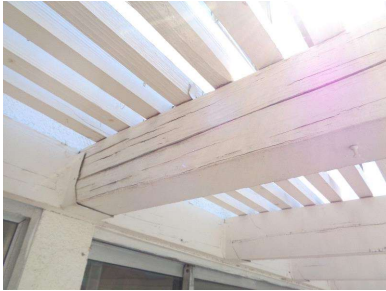
Materials: wood frame design, Conditions, Attention: Noted damage to patio cover.  
Repairs needed. Termite report may provide further information.

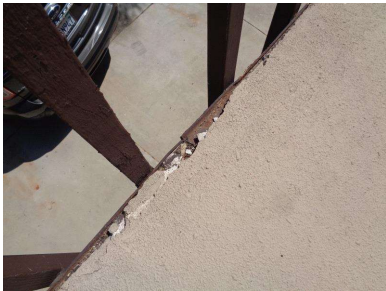
Light & switch appears serviceable Materials: Waterproof over plywood, Attention:  
Noted areas of deterioration. Repairs needed.

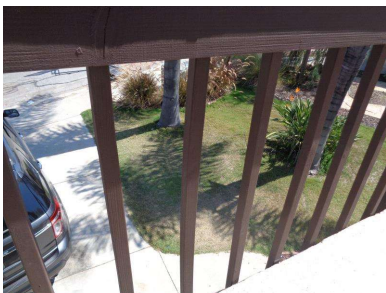
Attention: The guardrails installed have gaps greater than 4" between posts. This is a child safety hazard. Recommend correction.

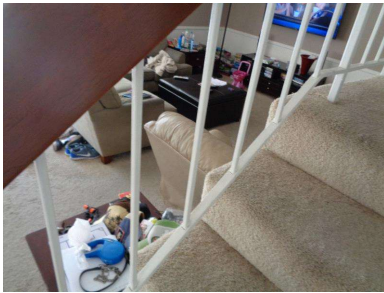
Material: Carpet, Conditions: Attention: Rail guard have openings of greater than 4" wide. This is a safety hazard for children. Recommend correction.

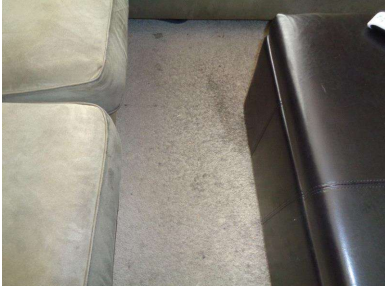
Type, Carpet, Attention: Noted stains in carpet. Could not determine if they could be cleaned or have to be replaced.

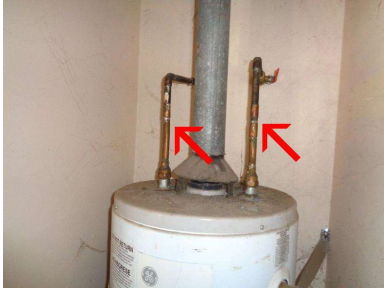
Conditions: The shutoff valve and visible water supply connectors appeared functional, they were not insulated. We recommend insulating the exposed water piping to minimize heat loss.

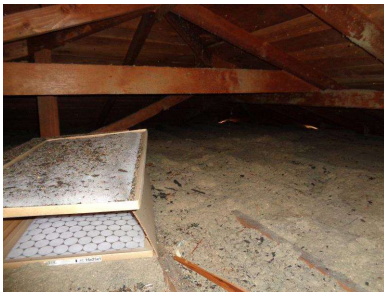
Materials: fiberglass batts, Conditions: The attic space had minimal insulation installed by today's standards. We recommend installing additional insulation for energy efficiency as an upgrade.

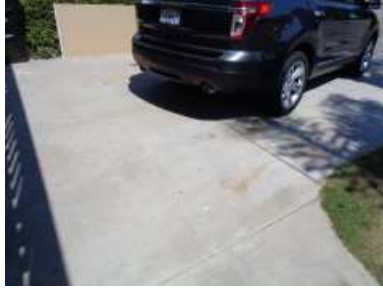
Attention: The driveway appeared functional with cracks noted. This is a normal occurrence over time. Recommend to monitor for any further deterioration.

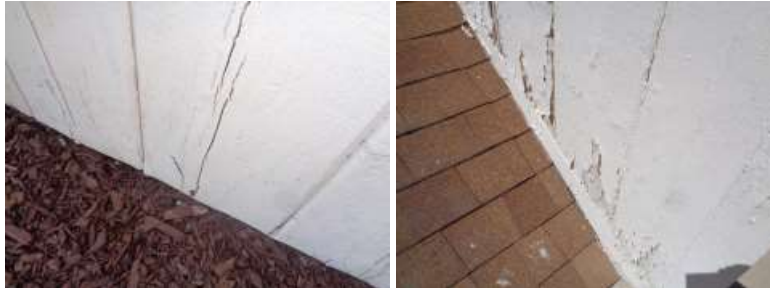
Combination of Stucco, Wood panels, CONDITIONS. Attention: The wood siding was damaged/deteriorated. These conditions are conducive to moisture intrusion/deterioration. Repairs or replacement needed.

Combination of Stucco, Wood shingles, CONDITIONS, Attention: The wood siding was damaged/deteriorated. These conditions are conducive to moisture intrusion/deterioration. Repairs or replacement needed.

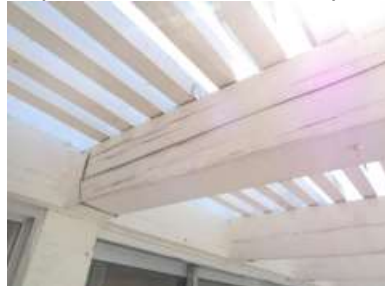
Materials: wood frame design, Conditions, Attention: Noted damage to patio cover. Repairs needed. Termite report may provide further information.

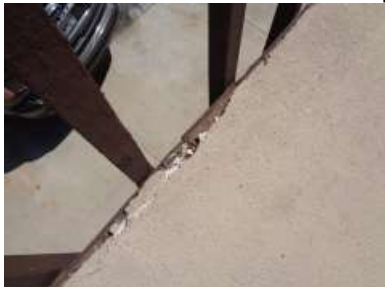
Light & switch appears serviceable Materials: Waterproof over plywood, Attention: Noted areas of deterioration. Repairs needed.

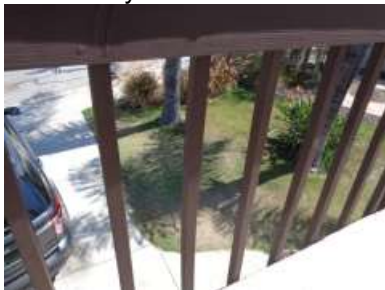
Attention: The guardrails installed have gaps greater than 4" between posts. This is a child safety hazard. Recommend correction.

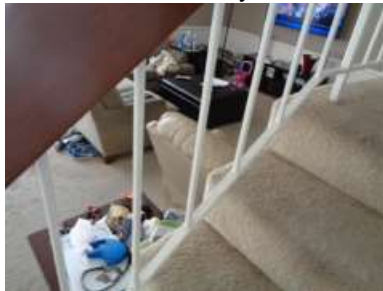
Material: Carpet, Conditions: Attention: Rail guard have openings of greater than 4" wide. This is a safety hazard for children. Recommend correction.

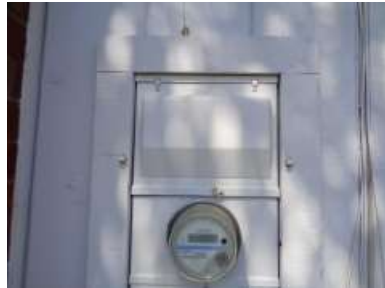
Size, 120/240 volt, rated at 100 Amperes, Brand, This property has a Zinsco brand electrical service panel. These panels and their breakers have a variety of problems including:- Arcing potential with aluminum bus bars and copper contacts on breakers· Bus bars made from aluminum that tend to oxidize and corrode· Breakers that don't trip under normal over-load conditions. At a minimum, recommend having a licensed electrician remove the breakers in the panel and evaluate the bus bars and breaker contacts. Recommend replacing damaged parts or the entire panel as necessary. If the panel isn't replaced, recommend installing a smoke detector above the panel. Recommend further evaluation by a licensed electrical contractor prior to removal of contingencies.

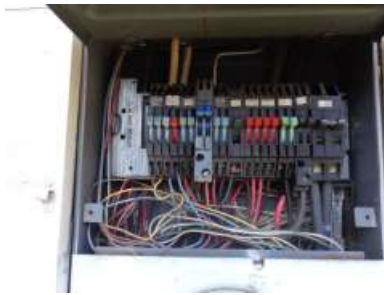
No legend available as dead panel cover is missing. Recommend placing dead panel cover and labeling breakers as soon as possible.

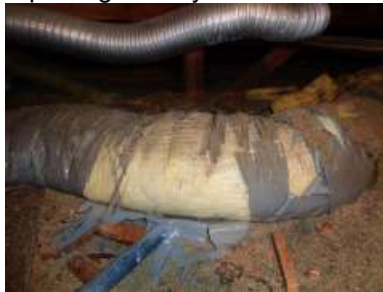
Plastic covered and insulated flexible ducting Conditions, Original duct system present. These ducts are usually very leaky. This hurts the efficiency of the units, causing shorter life expectancy and higher energy bills. The outer plastic covering on the conditioned air ducts was damaged. We recommend correcting the condition(s) noted. Recommend replacing duct system.

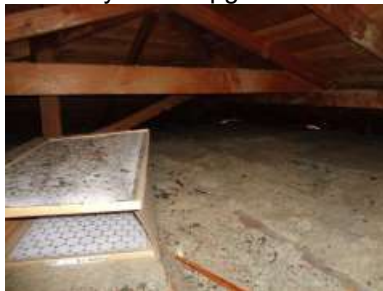
Materials: fiberglass batts, Conditions: The attic space had minimal insulation installed by today's standards. We recommend installing additional insulation for energy efficiency as an upgrade.
