# Inspection Report

111 A St

San Diego, CA 92126

Prepared for: John Client

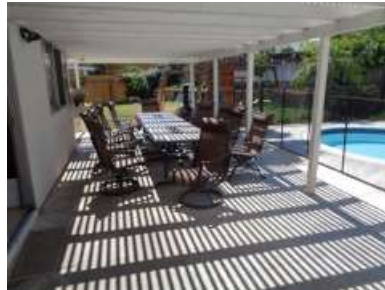
Rear.

Materials: concrete, Some cracks noted. This is a normal occurrence over time. Recommend to monitor for further deterioration. Light & switch appears serviceable, Outlet: Outlet weather protected and is GFCI protected.

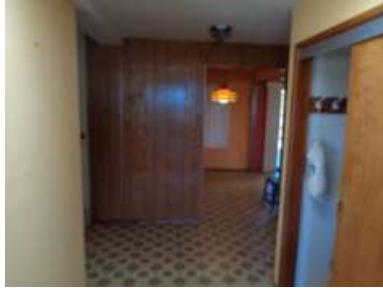
1st Floor.

Smoke detector noted. It was not tested as part of this inspection. Recommend testing and change batteries upon moving in.

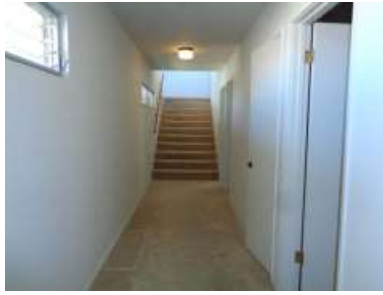
2nd Floor.

Smoke detector noted. It was not tested just presence noted. Recommend replacing batteries when occupying property.

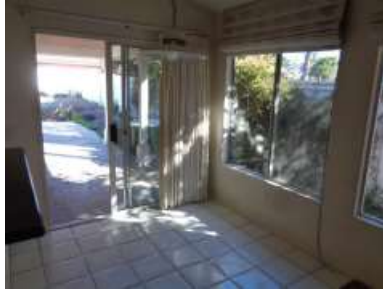
Middle.

Type: Vinyl Dual Pane, Horizontal, The accessible window(s) were functional, Attention: There were missing window screens. We recommend correcting the condition(s) noted.

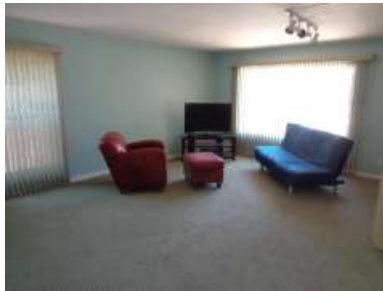
Rear.

Type, Carpet, Attention: Noted stains in carpet. Could not determine if they could be cleaned or have to be replaced.

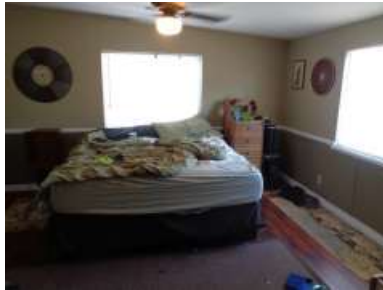
Front, 2nd Floor.

The door(s) were functional, Attention: Missing door stop. Recommend installation to prevent damage to wall.

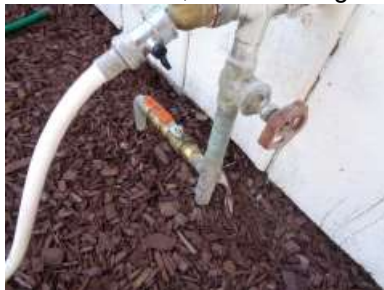
Location: Front, Pressure regulator, No pressure regulator installed.

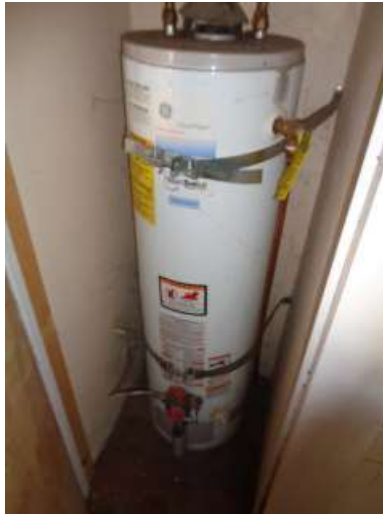
Unit was manufactured in 2011 . Average life expectancy of a water heater is 10-12 years.

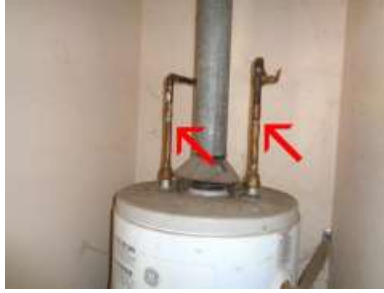
A temperature & pressure relief valve and discharge line were installed. The discharge line extended and terminated close to the ground facing downward.
